Advanced Composite Solutions

Blade fixing system failure – metal insert

Root Replacement

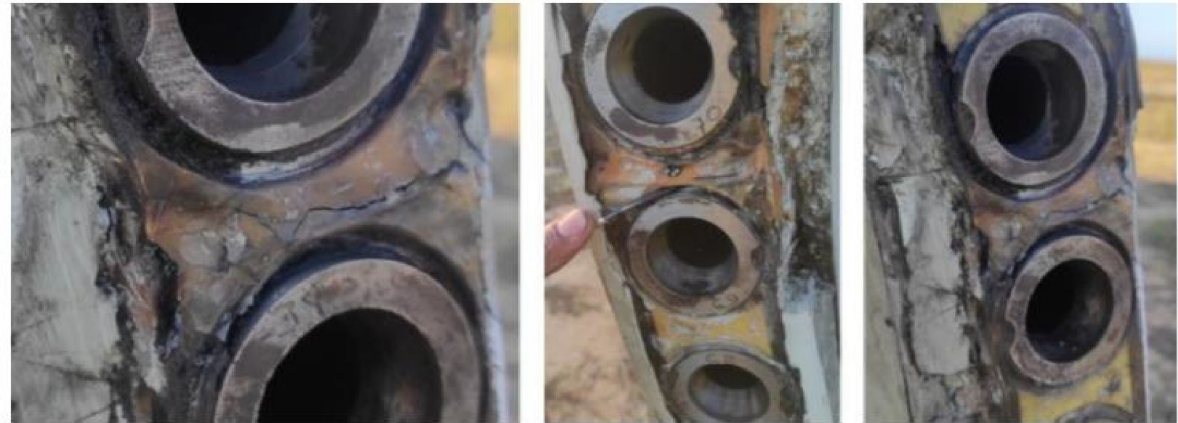
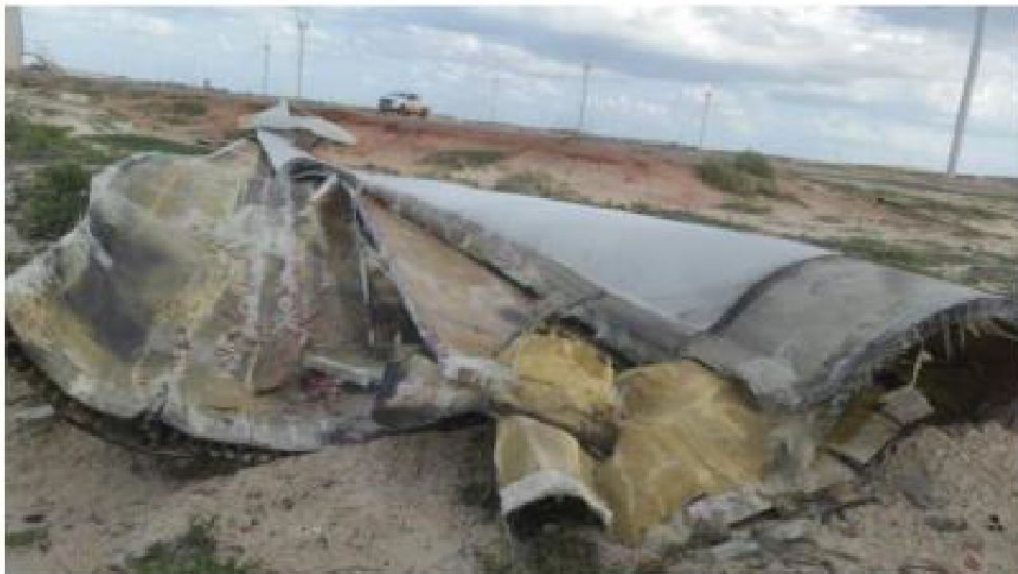
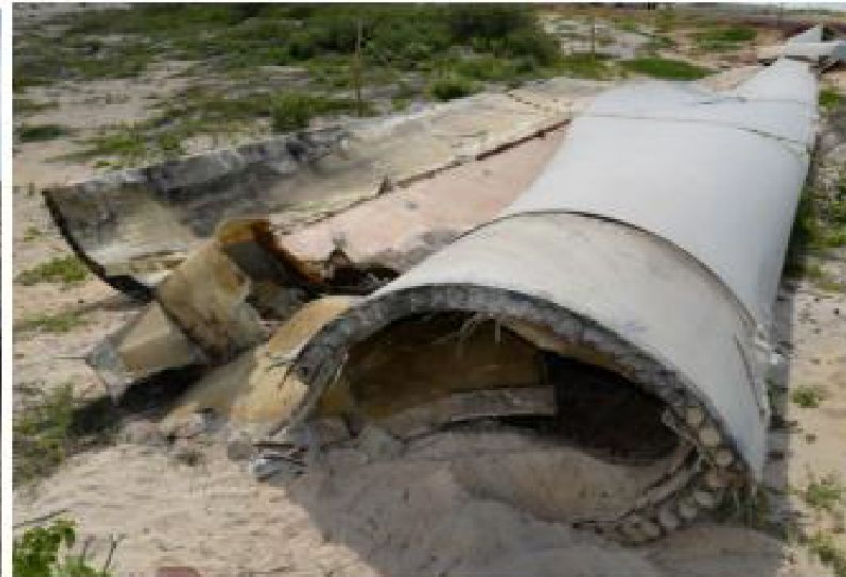
- Catastrophic damage
- Metal insert coming off the blade

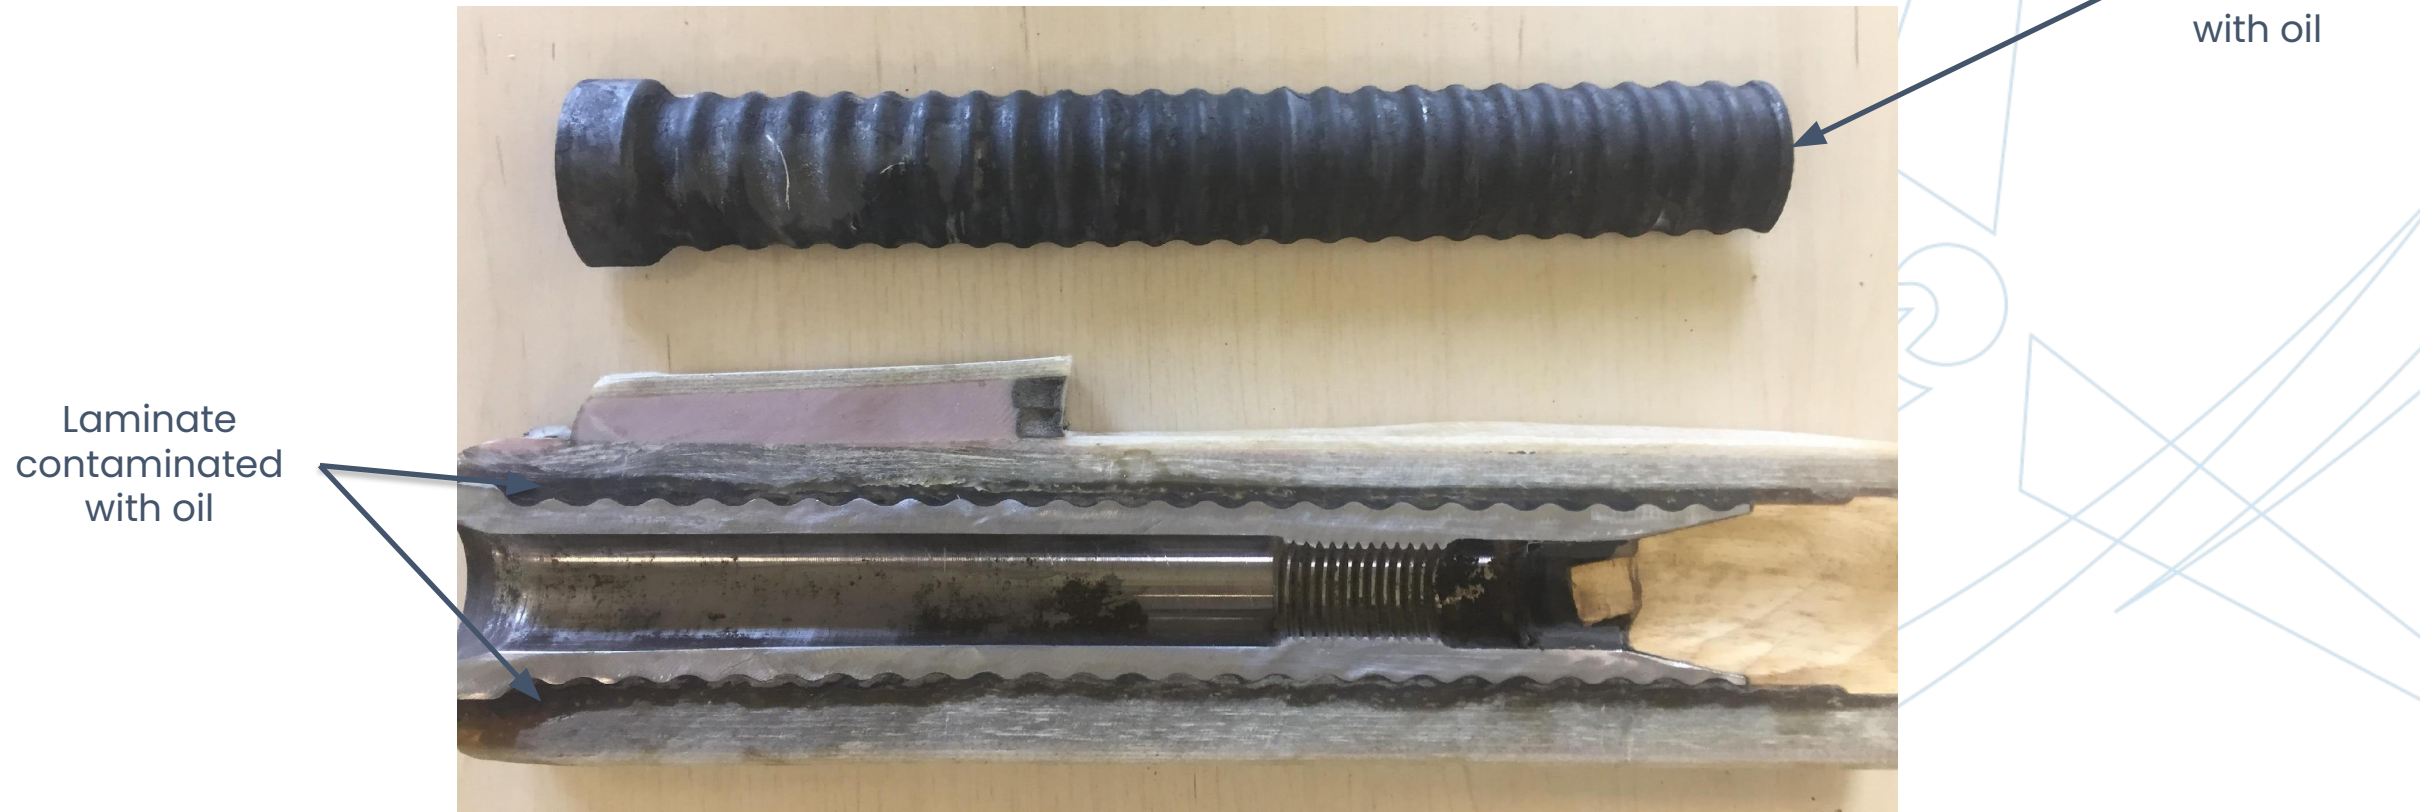
Contamination

Cut up for contamination analysis.

Metal insert completely detached from laminate/easy removal after cut in half
